F180 MANUAL CORRECTIONS

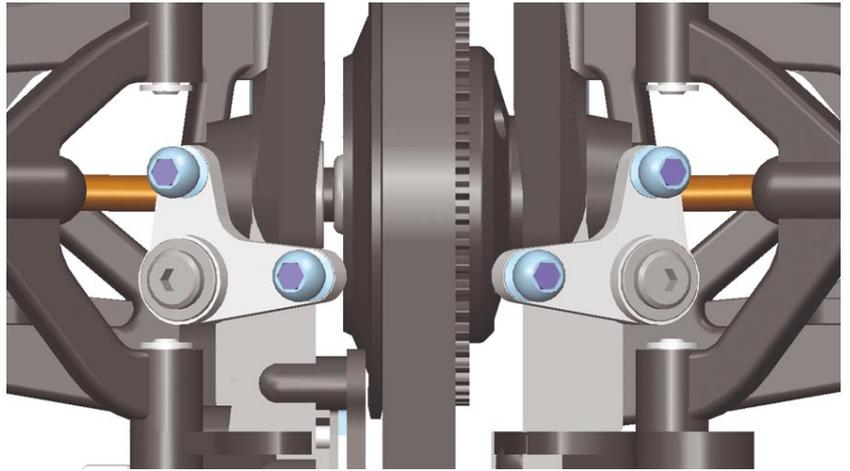
Page 11, step 2.10

The orientation of the rear rockers is incorrect in the manual. The image on the right shows the correct orientation.

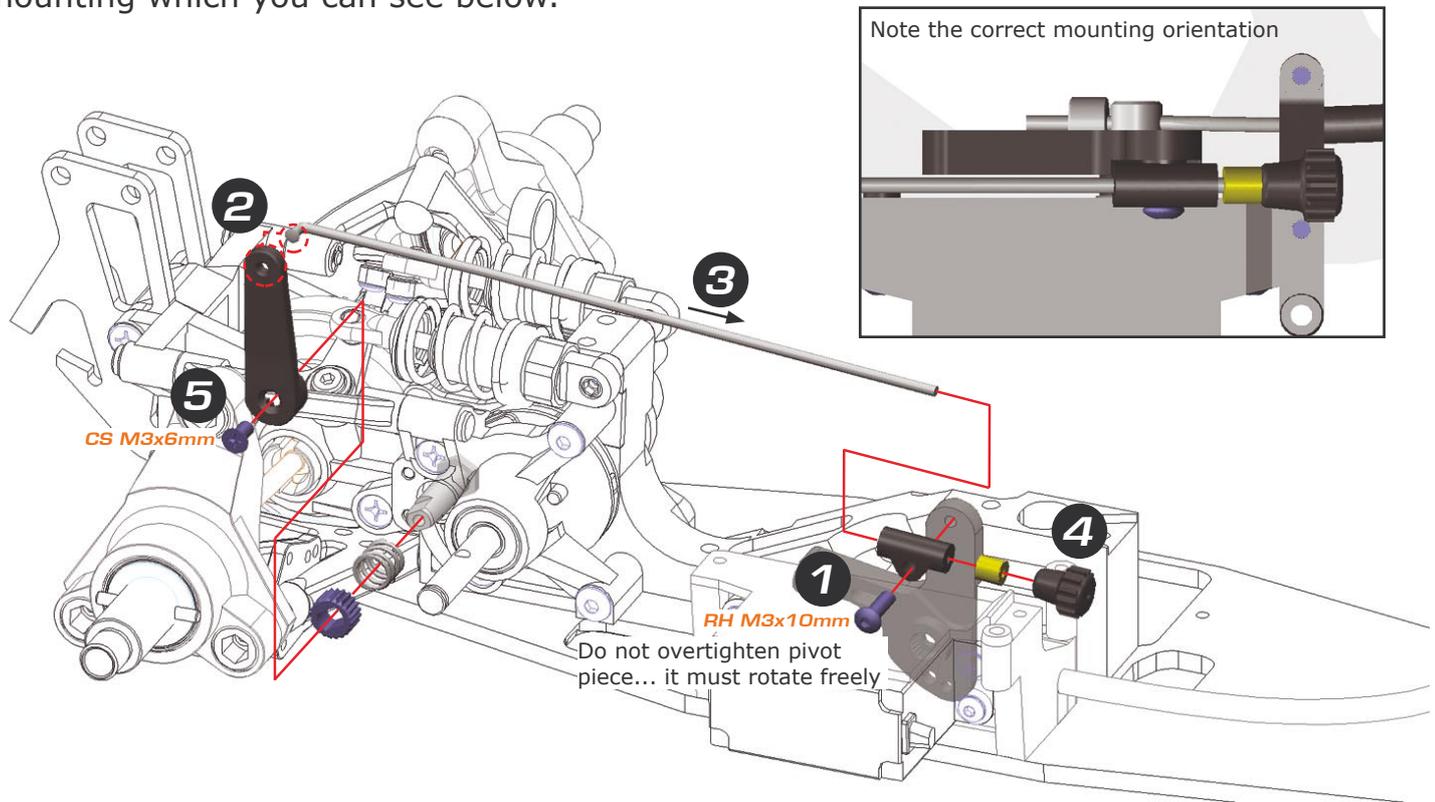
Page 20, step 4.8

This step has a new assembly order and clarifies the brake lever and servo arm mounting which you can see below.
